TENSILE TEST OF CORED REPAIR MATERIAL FROM NEWPORT BRIDGE PIERS

October 2004

Prepared for the Rhode Island Turnpike and Bridge Authority
by:

Michael Sock
Research and Technology
Rhode Island Department of Transportation

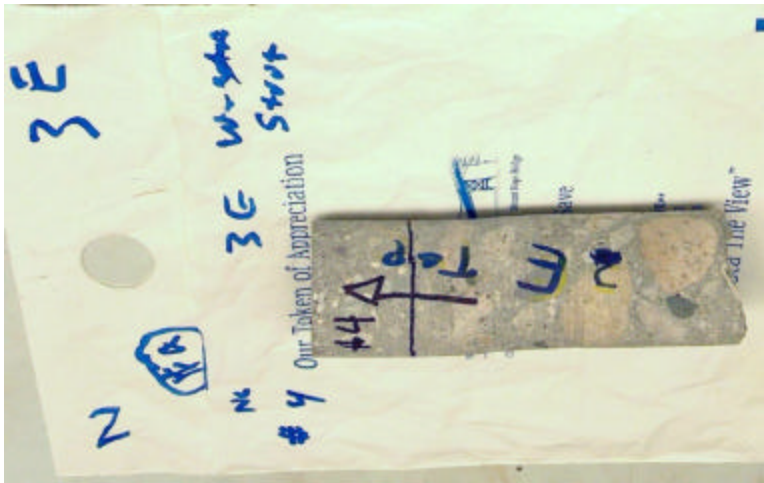
Figure 5 – Specimen 4 (uncut)

Core#4 – 1.25 inch thick patch with 0.5 inch nominal aggregate, more easily discernible from 1.5 inch nominal aggregate original concrete w/coarse aggregate in substrate shows terminus, total core length 5.5 inches. Bag Markings: #4, N, 3E, West Side Strut.

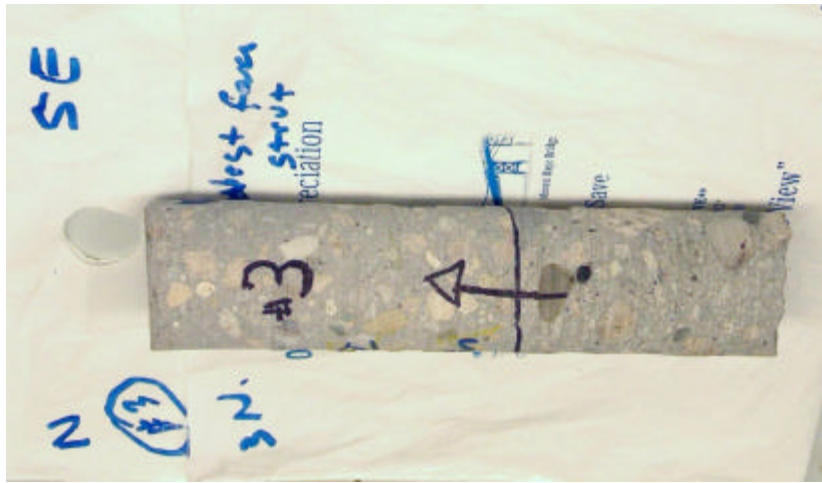
Figure 4 – Specimen 3 (uncut)

Core#3 – 4.5 inch thick patch with 0.5 inch nominal aggregate, not easily discernible from 1 inch nominal concrete w/mortar color main indicator of terminus, total core length 8.5 inches. Bag Markings: #3, N, 3N, 5E, West Face Strut.

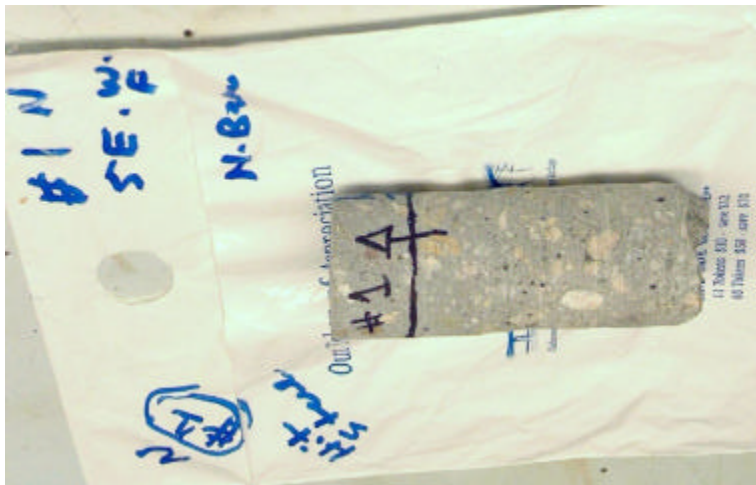
Figure 3 – Specimen 1 (uncut)

Core#1 – 0.75 inch thick patch with 0.5 inch nominal aggregate, not easily discernible from 1 inch nominal aggregate original concrete w/mortar color main indicator of terminus, total core length 4.5 inches. Bag Markings: #1, N, N. Beam, 5E, WF, Hit Steel

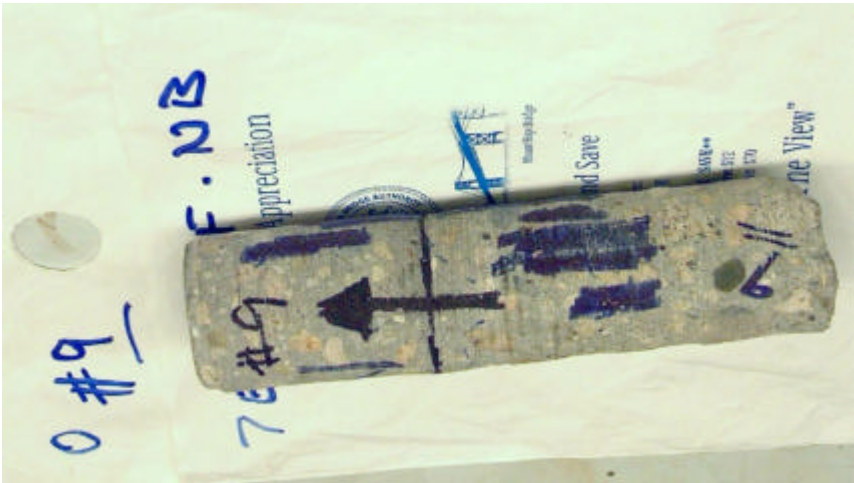
Figure 8 – Specimen 9 (uncut)

Core#9 - 2.875 inch thick patch with 0.5 inch nominal aggregate, very easily discernible from 1.25 inch nominal aggregate original concrete w/coarse aggregate size in substrate main indicator of terminus, total core length 6.5 inches. Bag Markings: #9, O, NB, 7E, EF.

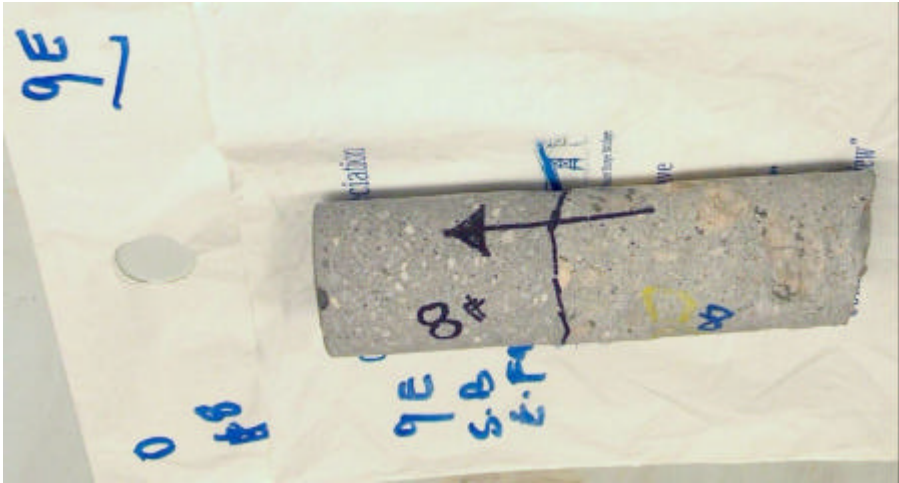
Figure 7 – Specimen 8 (uncut)

Core#8 – 2.75 inch thick patch with #8 nominal aggregate (see Figure 9), very easily discernible from 1.5 inch nominal aggregate original concrete w/patch

aggregate size main indicator of terminus, but mortar color difference is distinct, total core length 6 inches. Bag Markings: #8, O, SB, 9E, E. Face.

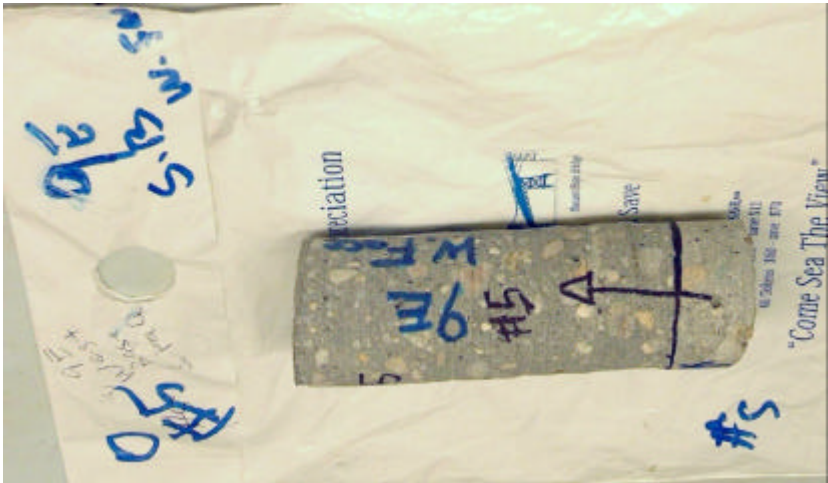
Figure 6 – Specimen 5 (uncut)

Core#5 – 4.5 inch thick patch with 0.5 inch nominal aggregate, more easily discernible from 1 inch nominal aggregate original concrete w/mortar color main indicator of terminus, total core length 5.25 inches. Bag Markings: #5, O, SB, 9E, W. Face.

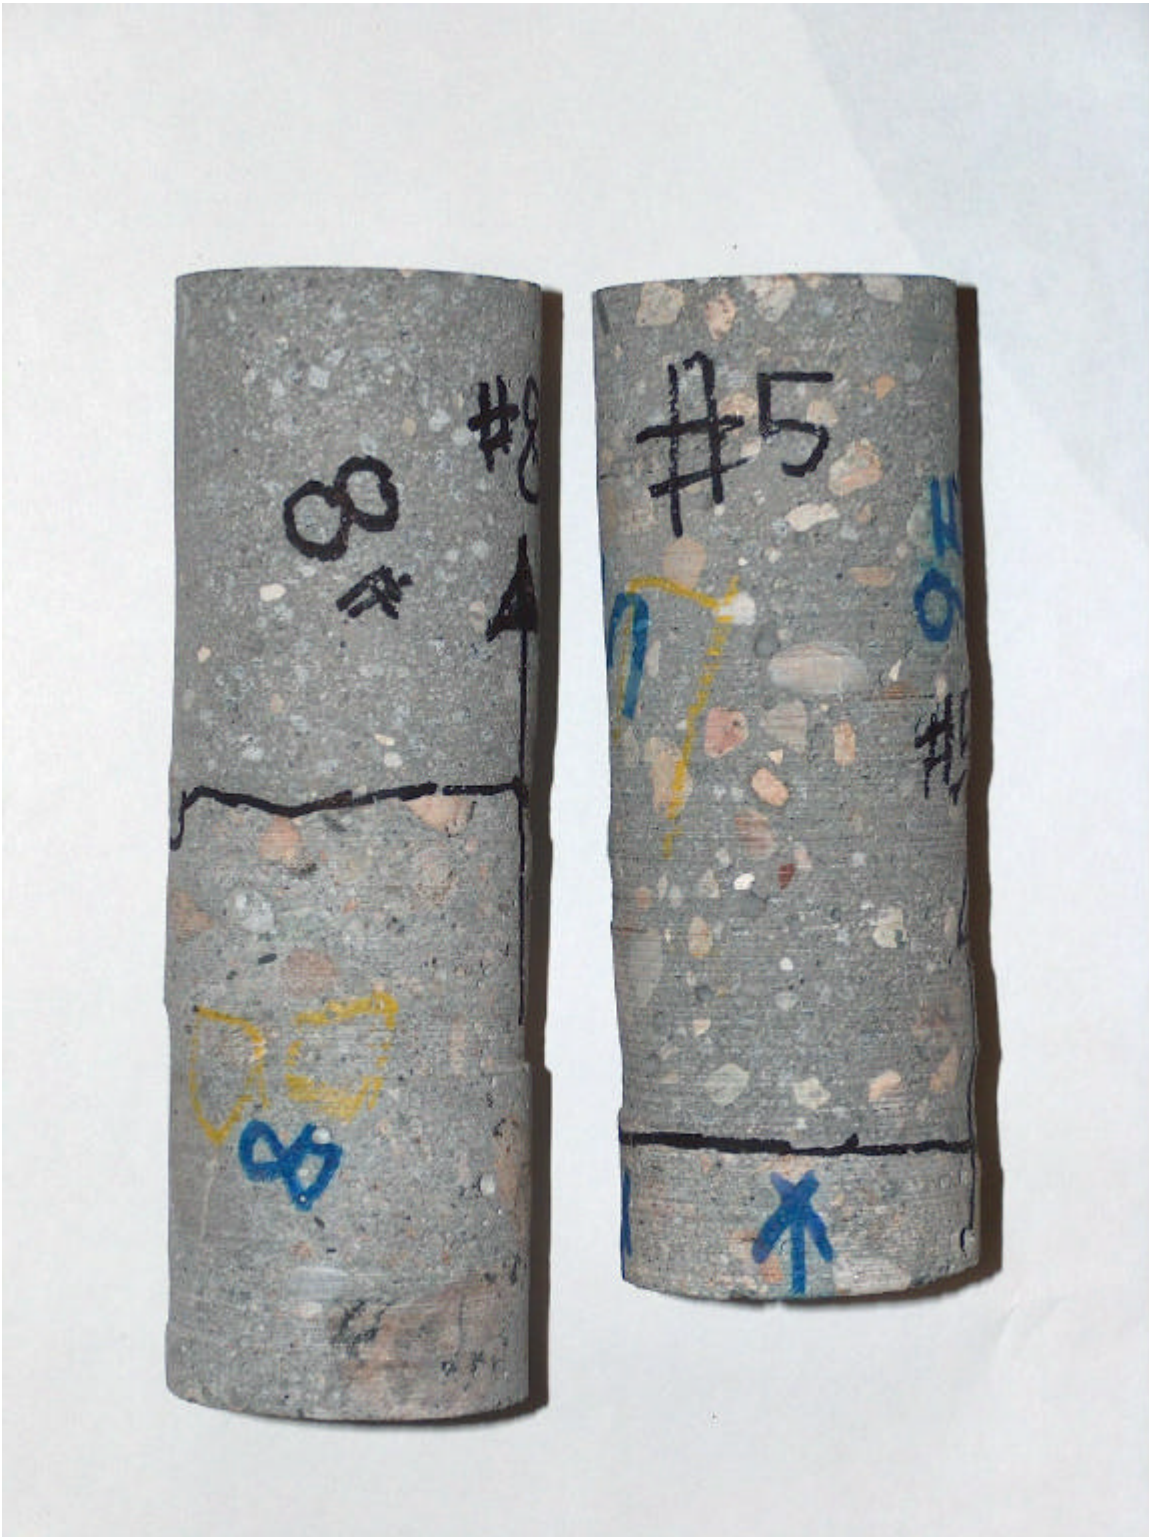
Figure 9 – Repair Material Aggregate Difference (Upper Section of Cores) between Core #8 and Other Cores (Core #5 Typical of Remaining Cores)

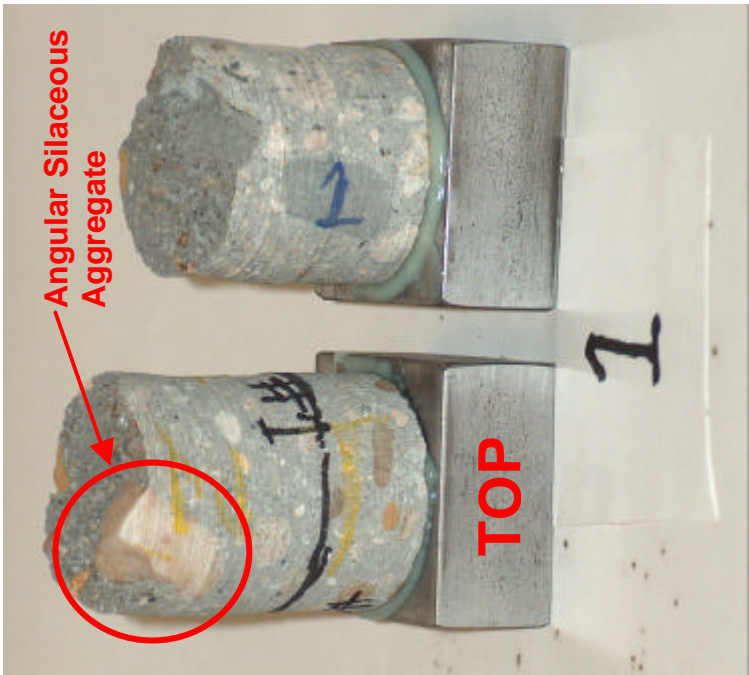
Figure 17 – Core 1 Break

Note that the break in core number 1 traveled around a large piece of angular silaceous aggregate in the substrate. There was no trace of mortar on the stone, indicating a minimal bond to the concrete matrix. That would have reduced the strength of the concrete in that location, resulting in the fracture. Core number 4 failed in the preloading

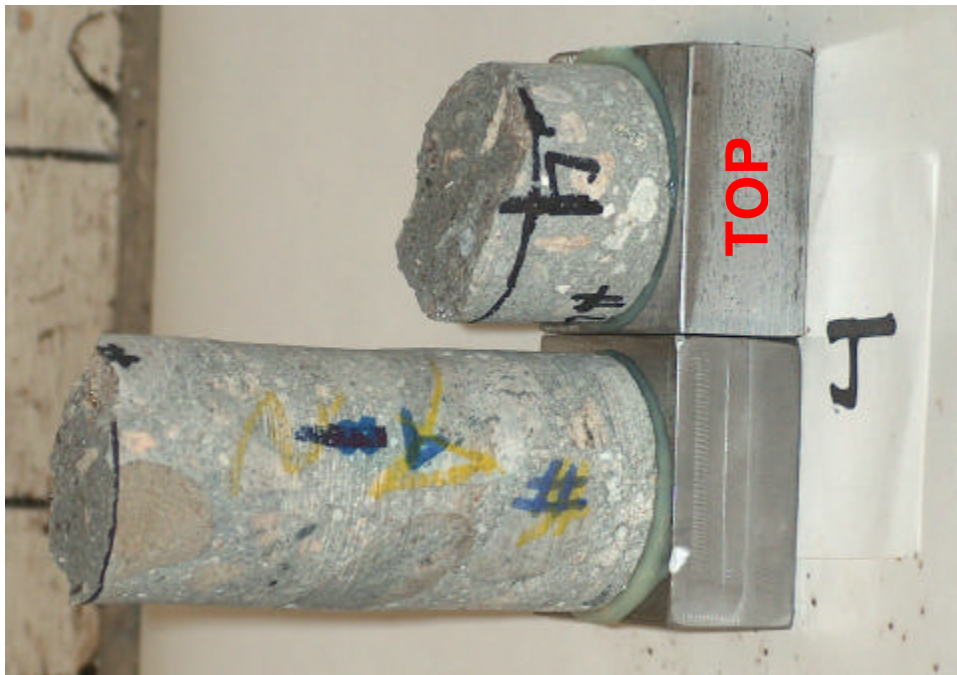
Figure 19 – Core 4 Break

of the specimen (so no loading rate is provided), but that appears to be anomalous behavior. It did, however, fail through the patch/substrate interface. Aside from number 4, the range of breaks was rather small, given the variables involved. Treating number 4 as an outlier, the mean was 173 psi (417 lbs), the standard deviation was 16 psi (38.4 lbs) and with a 95% confidence level of 20 psi (48 lbs). Neglecting number 1 changes the values only slightly and is therefore not seen to have a significant effect, indicating that the core would likely have broken in the interface within the range of the other specimens, if it had not failed where it did.
